Case Study

Dust Cloud Ignition caused by Static Electricity

Source: "Electrostatic Ignition of Fires and Explosions", Thomas H. Pratt, CCPS, (2000)

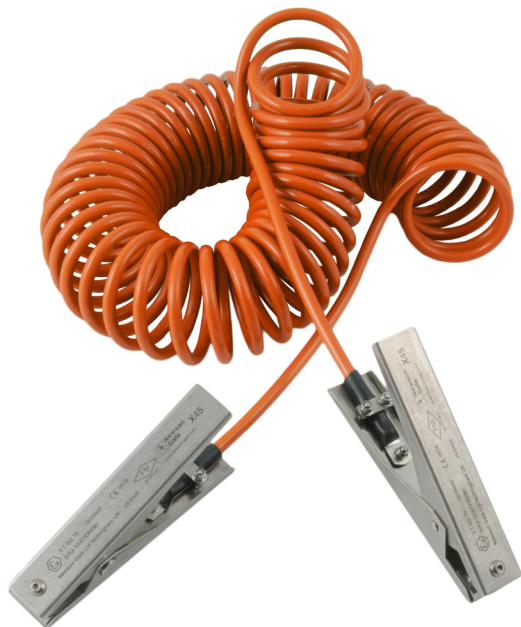
VESX45 – dual clamp assembly for connecting portable objects

Devices like the ones highlighted in the pictures below can be used to connect the drum to the grounded process vessel. At minimum a grounding clamp with FM/ATEX approvals, like the example in the picture on the left, should be specified so that any physical impedances like paint coatings and product deposits are fully penetrated to make contact with the base metal. The picture on the right shows a device that will inform the operator when he/she has achieved a connection resistance of 10 Ohms or less between a metal drum and the process vessel. This is indicated via a pulsing green LED mounted in the grounding clamp that provides the operator with a simple GO / NO GO instruction to tip the powder into the process vessel.

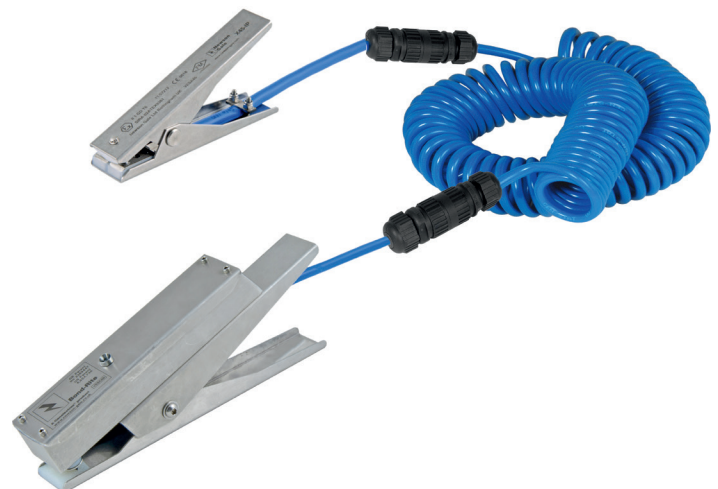
Bond-Rite® EZ with clamp mounted LED indicator that pulses green when a connection resistance of 10 Ohms or less is made between conductive portable equipment.
